International Journal of Arts, Humanities & Social Science ISSN 2693-2547 (Print), 2693-2555 (Online) Volume 03; Issue no 02: February, 2022

AGONY OF CIRCULATION IN THE BAMENDA METROPOLITAN AREA OF THE NORTH WEST REGION OF CAMEROON

Lesley Ntumngia N.¹, Lawrence Fombe F.²

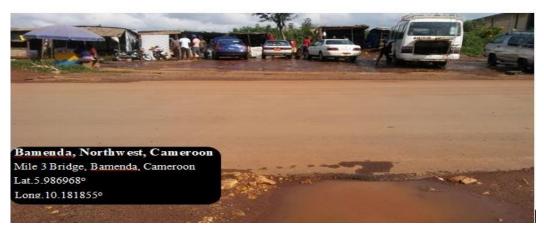
From Figure 5, 98.9% indicated that roads need pedestrian paths while 97.8% indicated the need for parking lots. Field work also assessed the conformity of roads with construction and engineering norms. Findings reveal that roads are not in conformity to the norms hence degrade faster. Engineer Ngwakongoh (2019) highlighted that a road has to last for at least 15 years. But the roads in Bamenda depreciate after two or three months preceding maintenance since sustainable materials such as bituminous sphelt or tar macadam are not used. Lack of human resources or unqualified personnel, limited funds for the maintenance and construction of roads and inadequacy of preliminary studies are some of the problems they encounter with respect to road maintenance. They highlighted repetitive investment and agony faced by people in their daily mobility from one part of the town to another. The absence of road signs/markings, narrow width of streets are some planning lapses identified as shown in Figure 6.

Figure 6: Absence of pedestrian paths, road signs/markings and parking lots along Mile 3 Bridge in Bamenda II Source: Ntumngia, 2019

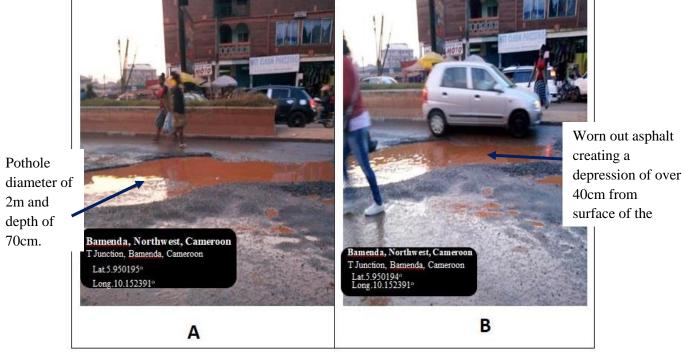
Photo by Ntumngia, August 2019

Figure 7: The poor surface state of most streets characterized by potholes

Figure 7 shows how potholes have become an endemic problem at T junction. Abrupt development in gradient due to degraded asphalt as shown in Figure 8 is a very common occurrence along most streets leading to pressure exerted on the springs/shocks and bumpers of vehicles and other fleets using such tracks.
